# **Styrene Gas Leak Incident Analysis in Vishakapatnam: Event Tree Analysis, Root Cause Analysis and Threat Zone Determination Using ALOHA Software”**

The Visakhapatnam gas leak incident happened on May 7, 2020, at LG Polymers chemical plant in RR Venkatapuram, Visakhapatnam district, Andhra Pradesh, India, resulted in fatalities and several injuries. This study is about a comprehensive analysis of the incident and also focuses on the causes of the gas leak, the nature of the chemical industry, the subsequent response and its impact on Environment and Human Health. A detailed study about styrene gas leaks, the chemicals involved, and also about styrene-related accidents, safety data, and relevant laws and acts governing chemical storage. The work identifies various factors contributing to the gas leakage, including tank design, temperature control, recirculation systems, inhibitor addition protocols, and the risk of polymerization and runaway reactions. Methodologies like ALOHA for threat zone

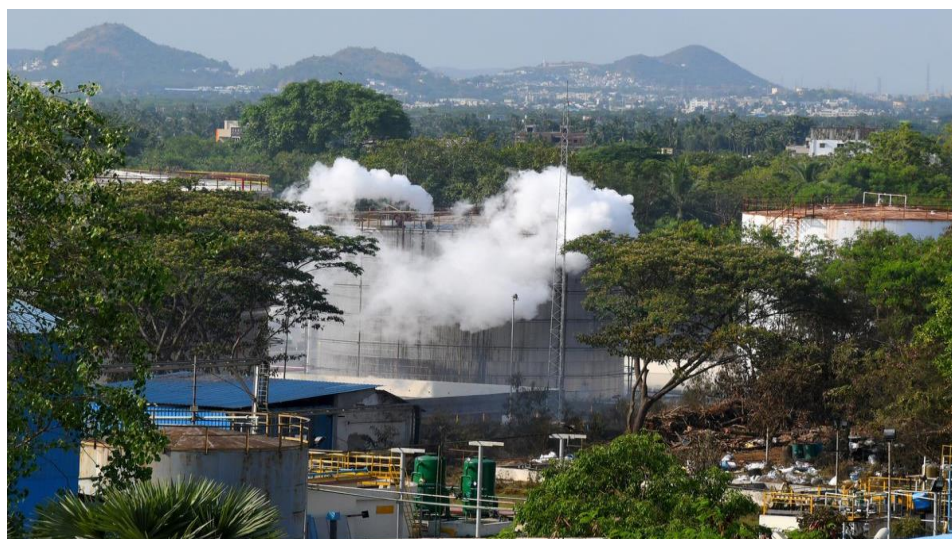
This Styrene vapour release, shown in Fig. 3 widely referred to as "Vizag Gas Leak", is a unique major Styrene vapour release incident from a bulk storage tank anywhere in the world. Nearly 20,000 people from 17,000 houses/residences of RRV Puram, Nandamuri Nagar, Kamparapalem, Padmanabha Nagar, SC/ BCColony, Meghadripeta Colony were evacuated, and arrangements were made at 23 rehabilitation centres maintained by GVMC as well as Simhachalam Devasthanam authorities [9]. Major factors leading to Styrene gas leak accident were as follows:

**Fig. 3. A file photo of styrene gas leaking out of a tank in LG Polymers unit, in Visakhapatnam**

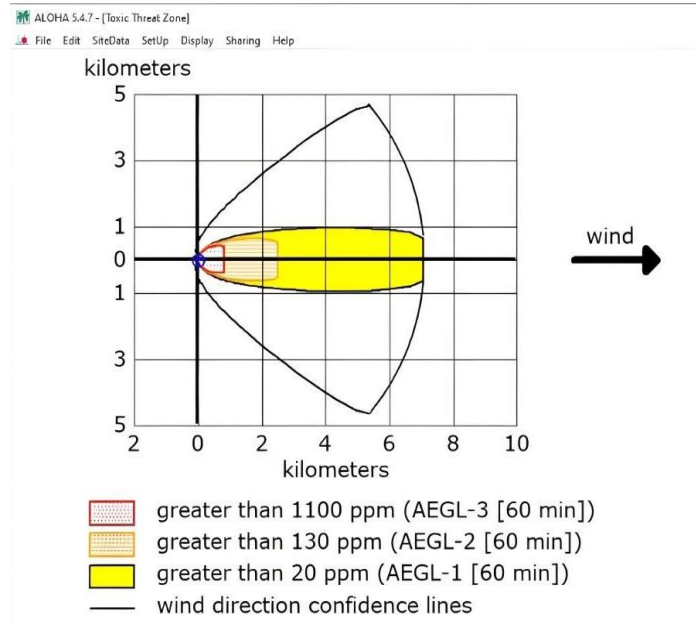
Fig. 4. Threat zone determination using ALOHA software

The total amount of styrene released from the M6 tank is 92,412 kilograms for a wind velocity of 3.22 mph from a south direction at a height of 20 m, an air temperature of 280 °C, and a relative humidity of 76%. The Red Zone of Acute Exposure Guidelines Levels 3 (AEGL 3 = 1100 ppm) is around 864 meters, which is the airborne concentration of a substance above which it is predicted that the general population, including susceptible individuals, could experience life-threatening health effects or death. The Orange Zone of Acute Exposure Guidelines Levels 2 (AEGL 2 = 130 ppm) is around 2.5 km, which is

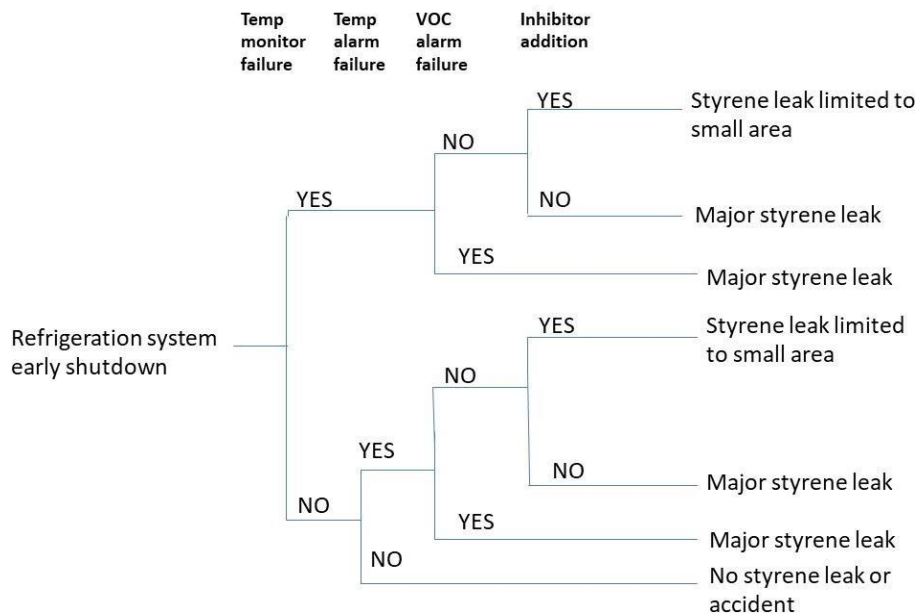
Fig. 7. Event tree analysis for refrigeration system shut down

Event tree analysis was employed to investigate the Visakhapatnam gas leak incident. The initiating event of the Vizag gas leak was identified as the early shut-down of the refrigeration system of the styrene storage unit.

ETA is used to predict the consequences of the initiating event (ie) early shutdown of refrigeration system which leads to the major accident if.

- Failure of both temperature and VOC alarms
- Failure of Inhibitor addition

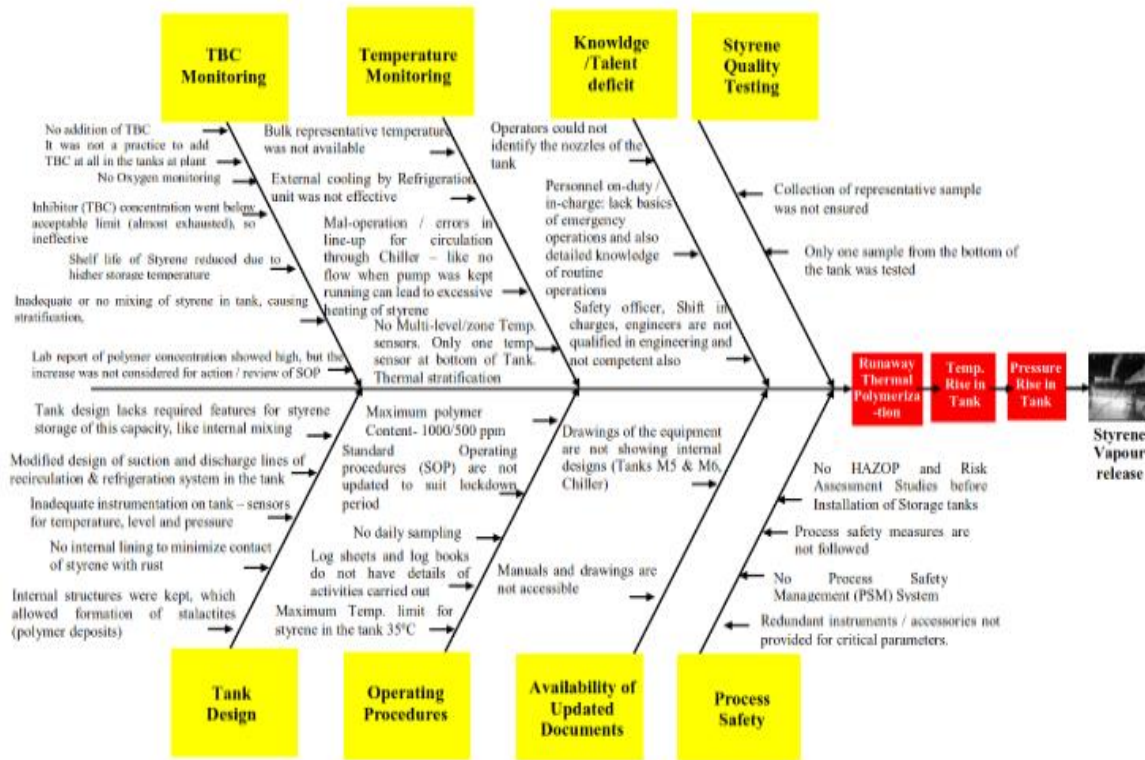
Fig. 8 Ishikawa Fish bone diagram for Vizag Gas Leak

- 1) 53-year-old atmospheric mild steel without any inside lining, insulated outside
- 2) 17 nozzles were used.
- 3) Conical roof on an inside structure
- 4) Provided with a re-circulatory cooling system
- 5) Change of design in the suction and discharge. No HAZOP and risk assessment for the modified design that falls under the management of change under the OSHA PSM standard
- 6) The last cleaning and maintenance of the tank was in 2015. Recommended cleaning every 2 years.

- 1) Single temperature measuring probe at the bottom of the tank, M6
- 2) Temperature measurement is restricted to the bottom zone; the top and middle zones might have different temperatures.
- 3) Thermal stratification in the tank
- 4) Temperature protocol of LG Polymers: 350 °C
- 5) Tank top temperature is 41.7 °C, estimated from DCS level percentage data recorded on April 28, 2020.
- 6) Incorrect assumption of the bottom temperature as the bulk temperature of the tank
- 7) Inadequate time for cooling

- 1) No addition of TBC in the on-site storage tanks since the last 10 year
- 2) Unavailability of TBC Stock
- 3) TBC stratification in the tank due to inefficient mixing in the tank design
- 4) Decrease in TBC concentration in styrene. Unaware of inhibitor depletion characteristics

- Incorporate suction wing pipe and educator system for efficient mixing.
- Ensure effective cooling systems with backup cooling to maintain a maximum temperature of 25°C.
- Keep the number of nozzles in the tank to a minimum required.
- Construct the tank with carbon steel and coat the inside with rust-resisting inorganic zinc silicate material.

- Support the tank roof without side structures.
- Paint the outside of storage tanks white or aluminum and consider insulating them.
- Define tank life and carry out tank cleaning and coating every two years.
