Management of Climatic Degraded Embankment of the River Nakanbé (Burkina Faso) by Participatory Reforestation

Short Research Article

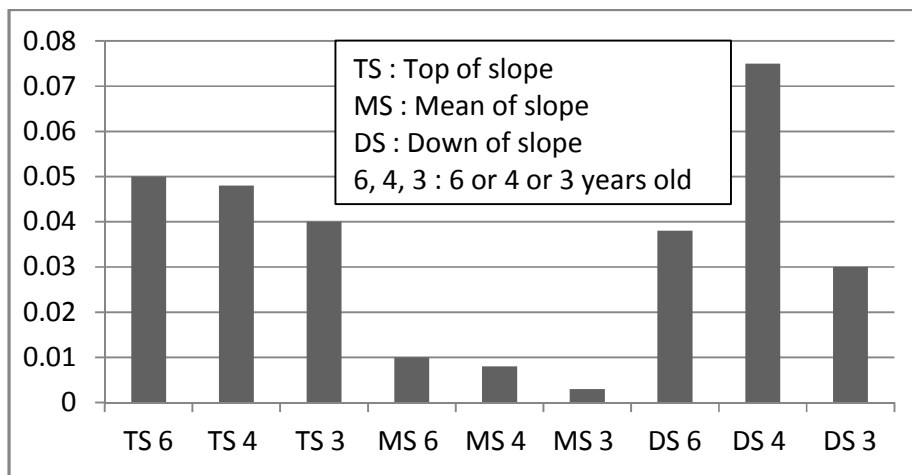
Fig. 2. Ratio of woody species according to the oldness of reforested banks
 TS = top of slope; MS = mean of slope and DS= down of slope

The analysis of the number of woody species by age of reforestation (Fig. 2), in high and medium slope, the number of plants show non-significant growth with the age of reforestation ; at the bottom of the slope, the 4-year-old reforested bank has the most significant tree population (0.075 individuals/m²).

The analysis of the number of woody species by age of reforestation (Fig. 2) show, in high and

medium slope, non-significant growth with the age of reforestation; at the bottom of the slope, the 4-year-old reforested bank have the most significant tree population (0.075 individuals/m²).

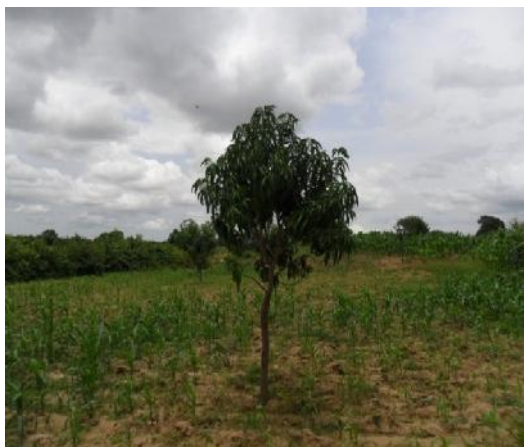
Picture 1. Area destroyed by the 2007 flood, 4 years after

The small number observed on medium slope of the banks of 4 years (Picture 1, appendix) is due to the 2007 flood which destroyed almost all the plantations of 2006 (Picture 2, appendix). Flooding could also be the cause of the growth retardation observed in the plants of the 6-year-old reforested banks compared to those of the 4-year-old reforested banks. Indeed, the excess of water creates anaerobic conditions that alter the root metabolic functions, lead to poisoning and cause the deterioration of the physical properties of the soil and make them more vulnerable to degradation. The oxygen required for root breathing, circulates in the interstices of the ground. In case of flooding, water occupies all these pores and the roots are placed in an asphyxiated condition, which inhibits their growth. Plants can survive short periods of anaerobic condition (up to 0.5% oxygen). Roots require 6-8% oxygen to grow normally. Under these values the leaves become chlorotic, the growth is interrupted, the formation of new roots stop, the stems become dry and the plant dies. Flooding can also reduce sweating by almost 90%, limiting the absorption of water and nutrients and reducing photosynthesis. These anaerobic conditions at the soil level are combined during insufficient drainage of heavy soils during heavy rains and flooding [13].

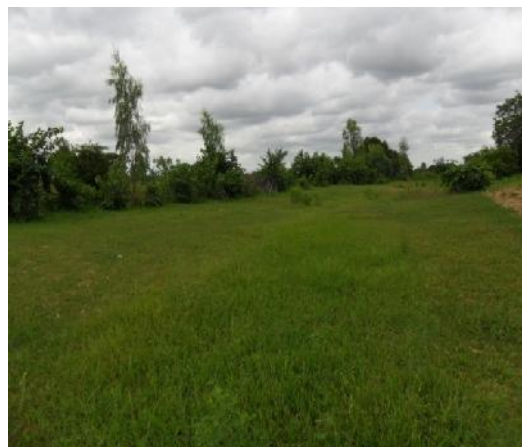
Picture 3. Average slope of banks of 3 years old

The mean slopes of the reforested 3-year-old banks are a fallow not replanted by lack of mango trees (Picture 3, appendix), hence the number of plants very low compared to other parts of the banks.

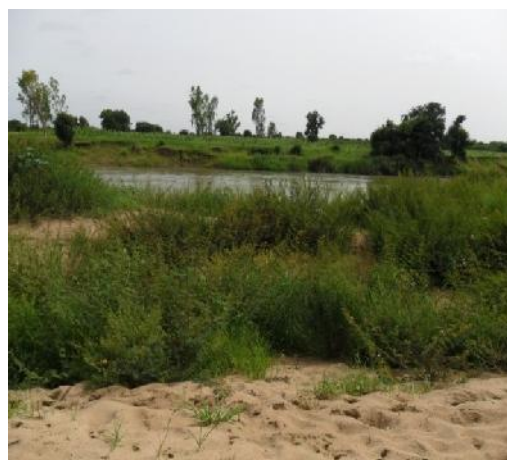
Picture 4. Sandy bank

The decline in silt content in soils at the top of the slope, as well as their increases at the bottom of the slope, show that there is leaching of the silts from the top to the bottom of the slope. The higher grades of sand at the bottom of the slope reflect a silting phenomenon (Picture 4, appendix). The slope intervenes in the degradation of the land by its declivity, length and form. The soil erosion increase exponentially with the slope [14]. The increase in the degree of slope lead to increasing of runoff [15].

The low slope plots are in the flood plain of the Nakanbé, where the phenomenon of sandy alluvial deposits is more important (Picture 4, Annex). However, the sand content decline at the bottom of the slope showing that reforestation allowed the retreat of silting. Similarly, the increase in clay contents over time indicates that reforestation increase the fine texture of soil content. Clay minerals make the soils heavier and therefore improves the stability of the banks.
